APOLLO 4

ANOMALY REPORT NO. 12

DAMAGE TO RECOVERED MAIN PARACHUTE

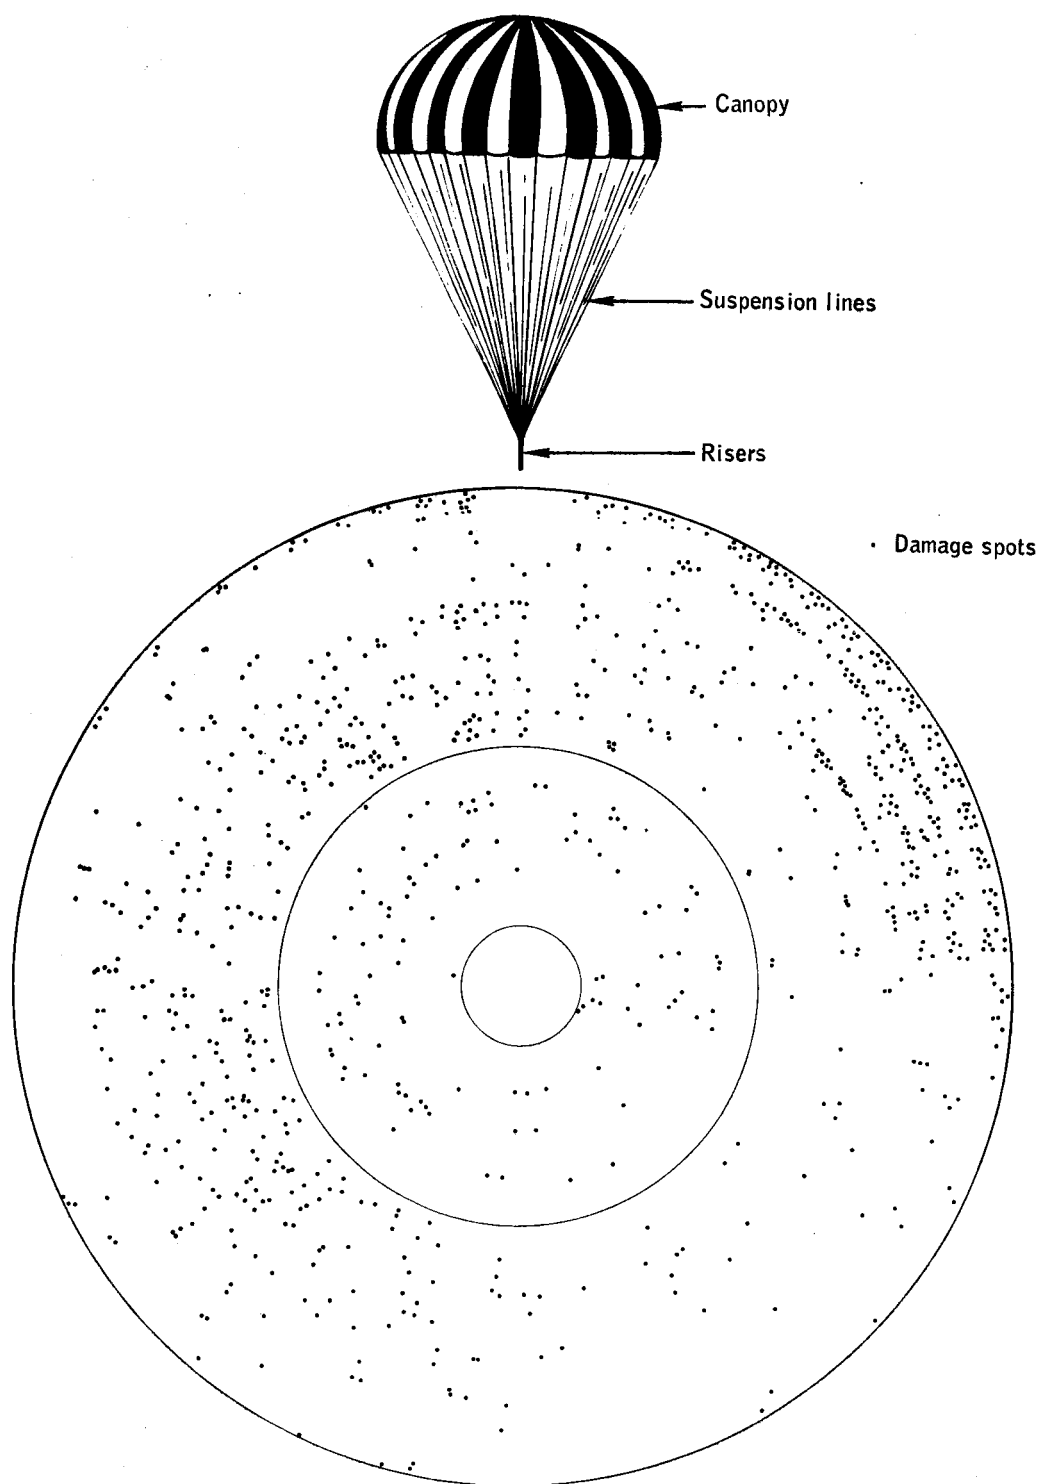
Damage charting of the main parachute (fig. 1) revealed numerous, small burn holes, varying from 1/100 to 1/16 inch in diameter, with a few sporadic holes varying from 1/4 to 1/2 inch. The majority of the holes in the first nine (of twelve) rings were approximately circular, whereas some of the holes in the lower three rings were elongated slots. This variation in hole shape from the crown to the skirt indicated that the damage occurred when the parachute was fully deployed.

Figure 1.- Hole dispersion pattern.

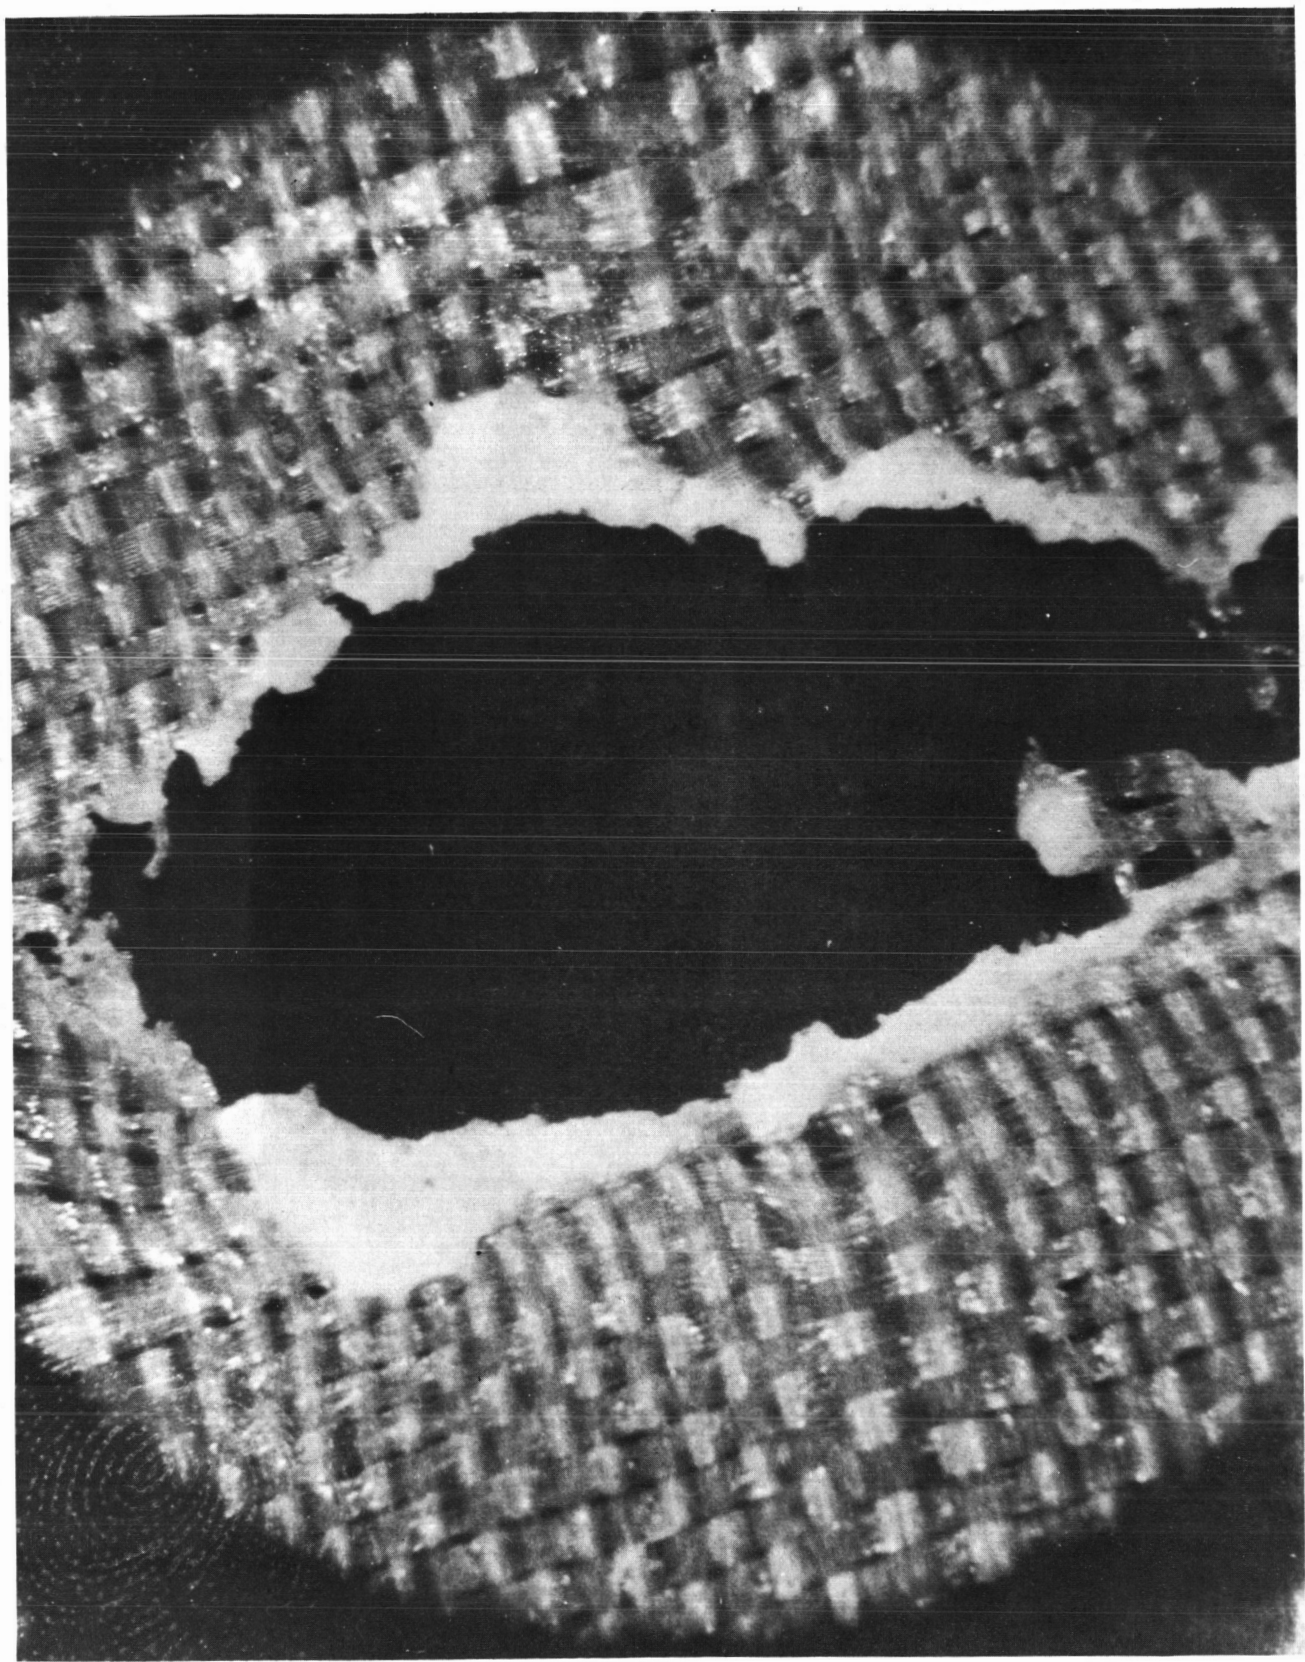
A sample piece of nylon cloth was exposed to concentrated liquid nitrogen tetroxide and then rinsed with water. Holes were produced that were very similar to those found in the flight-damaged parachute (figs. 2 and 3).

Figure 2.- Microphotograph of hole in parachute canopy.

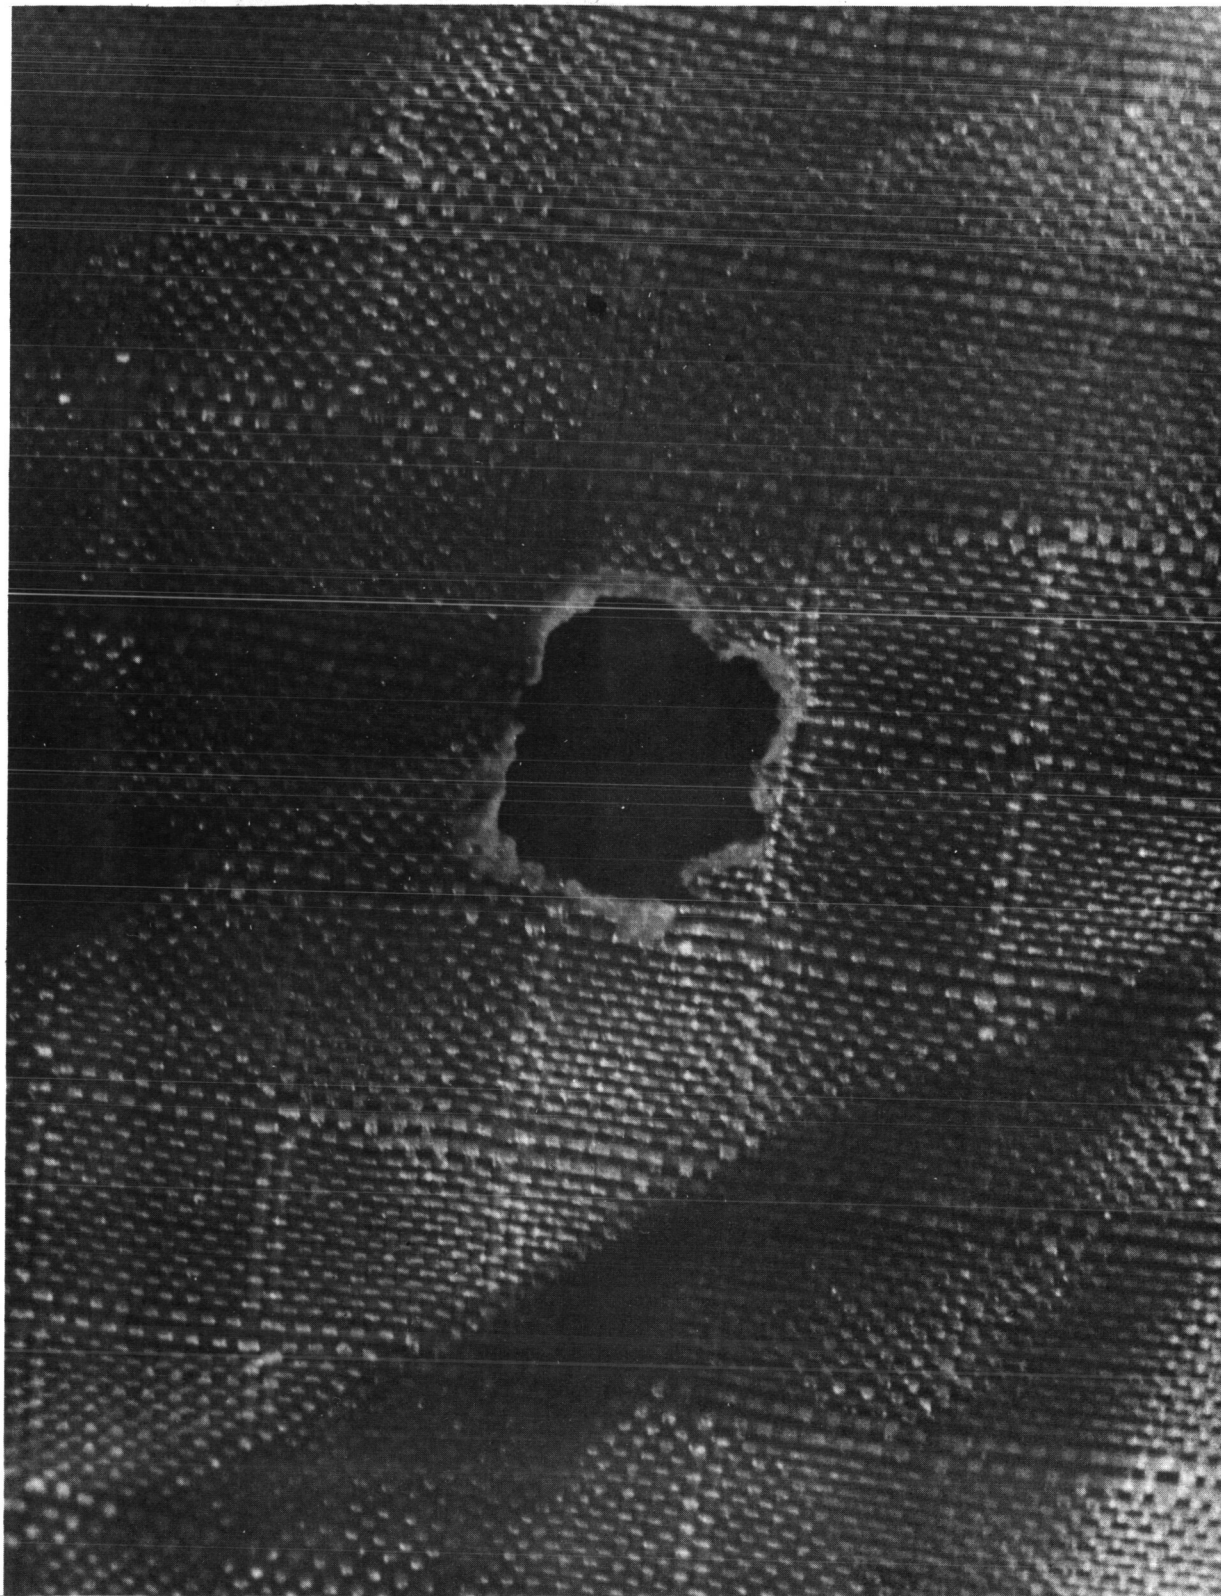
Figure 3.- Oxidizer damage to nylon.

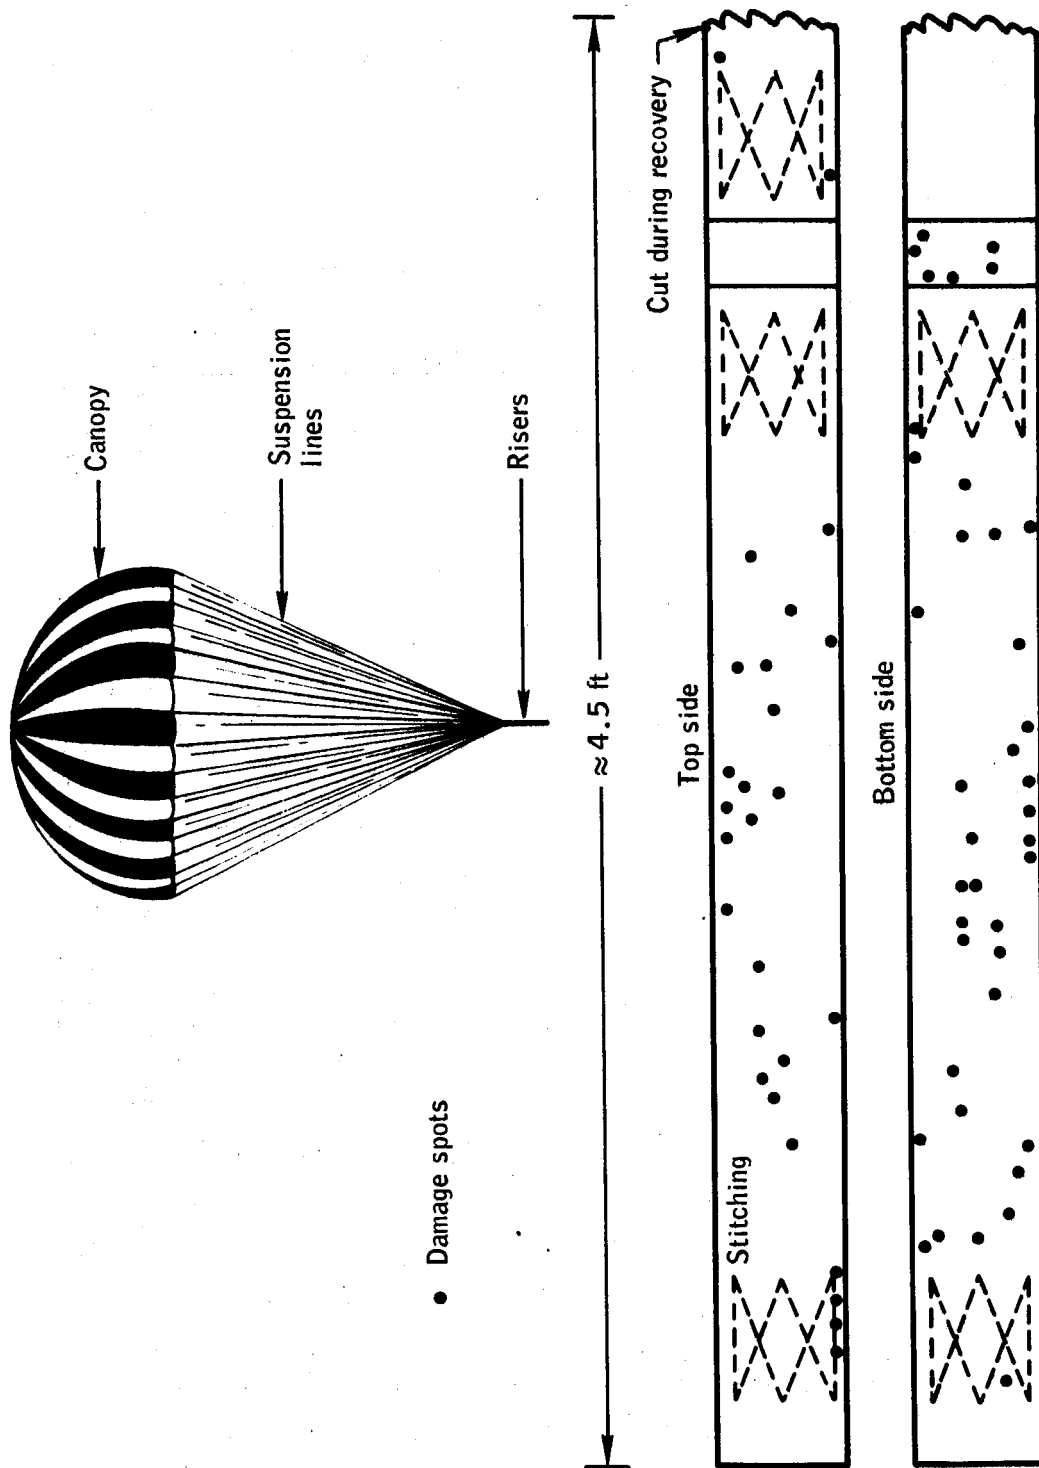
Chemical analyses of numerous yellow spots found on the parachute risers and suspension lines (figs. 4 and 5) yielded positive identification of nitrates, nitrites, and nitroso- compounds, which would be expected from oxidizer.

The breaking strengths of the most severely degraded samples of the suspension lines ranged from 430 to 670 pounds (nominal rated strength is 650 pounds). The breaking strength of riser material ranged from 7800 to 8100 pounds (rated strength is 11 000 pounds). The tensile strength of the cloth tested was 51 to 56 lb/in. (specification is 42 lb/in. minimum).

Figure 4.- Typical riser damage.

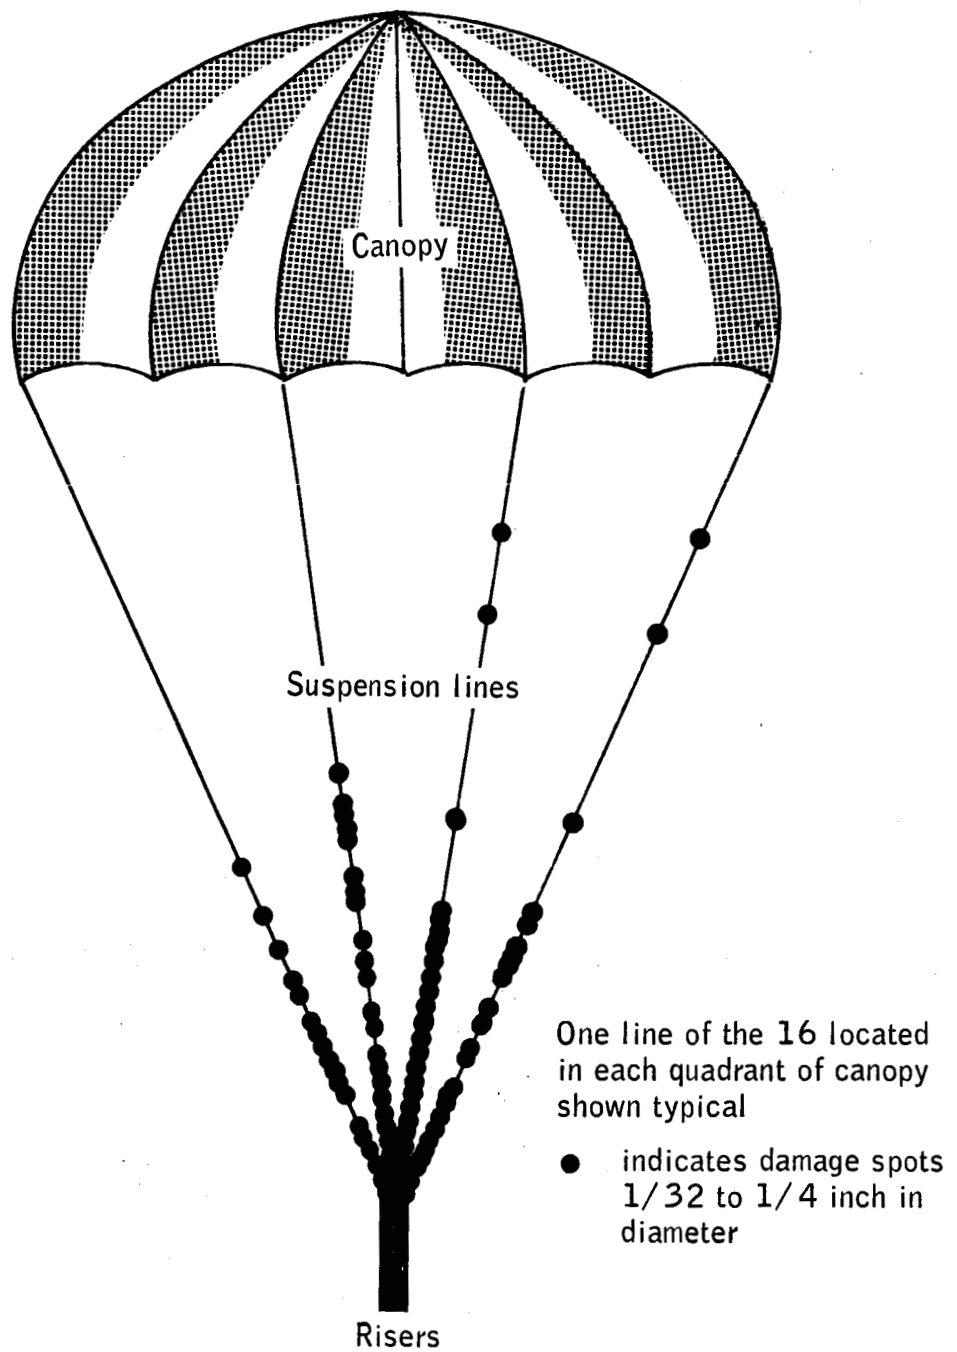
Figure 5.- Typical suspension line damage.

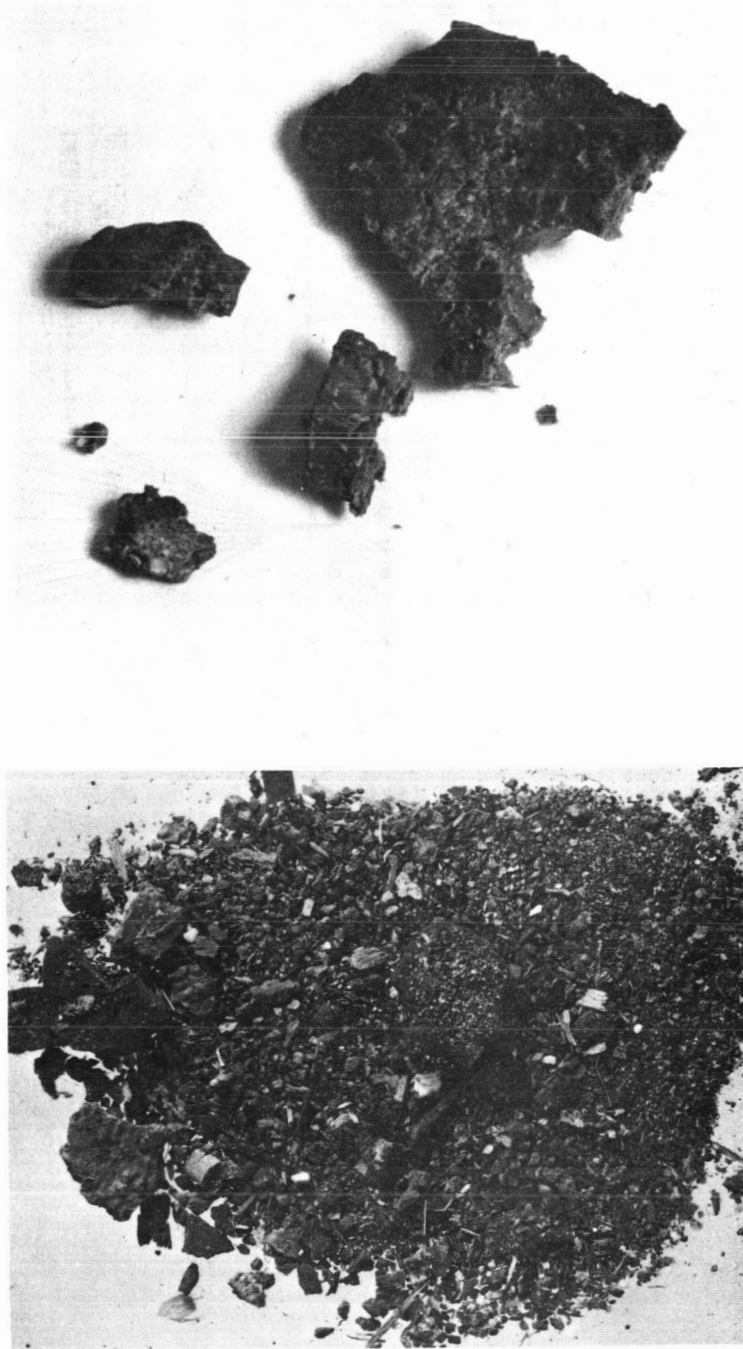
The debris (fig. 6) in the canopy was paint chips, sand, wood, nylon, aluminum and brass filings, glass, and caulking compounds accumulated during retrieving, handling, and transporting the parachute from the landing site to the contractor's facility.

Figure 6.- Foreign material collected from parachute.
